FINAL REPORT

FIELD RECONNAISSANCE AND  
WETLAND ASSESSMENT OF THE  
LEEDS SILVER SITE  
LEEDS, UTAH

JULY 1992

Mark D. Sprenger, Ph.D.  
Environmental Response Team

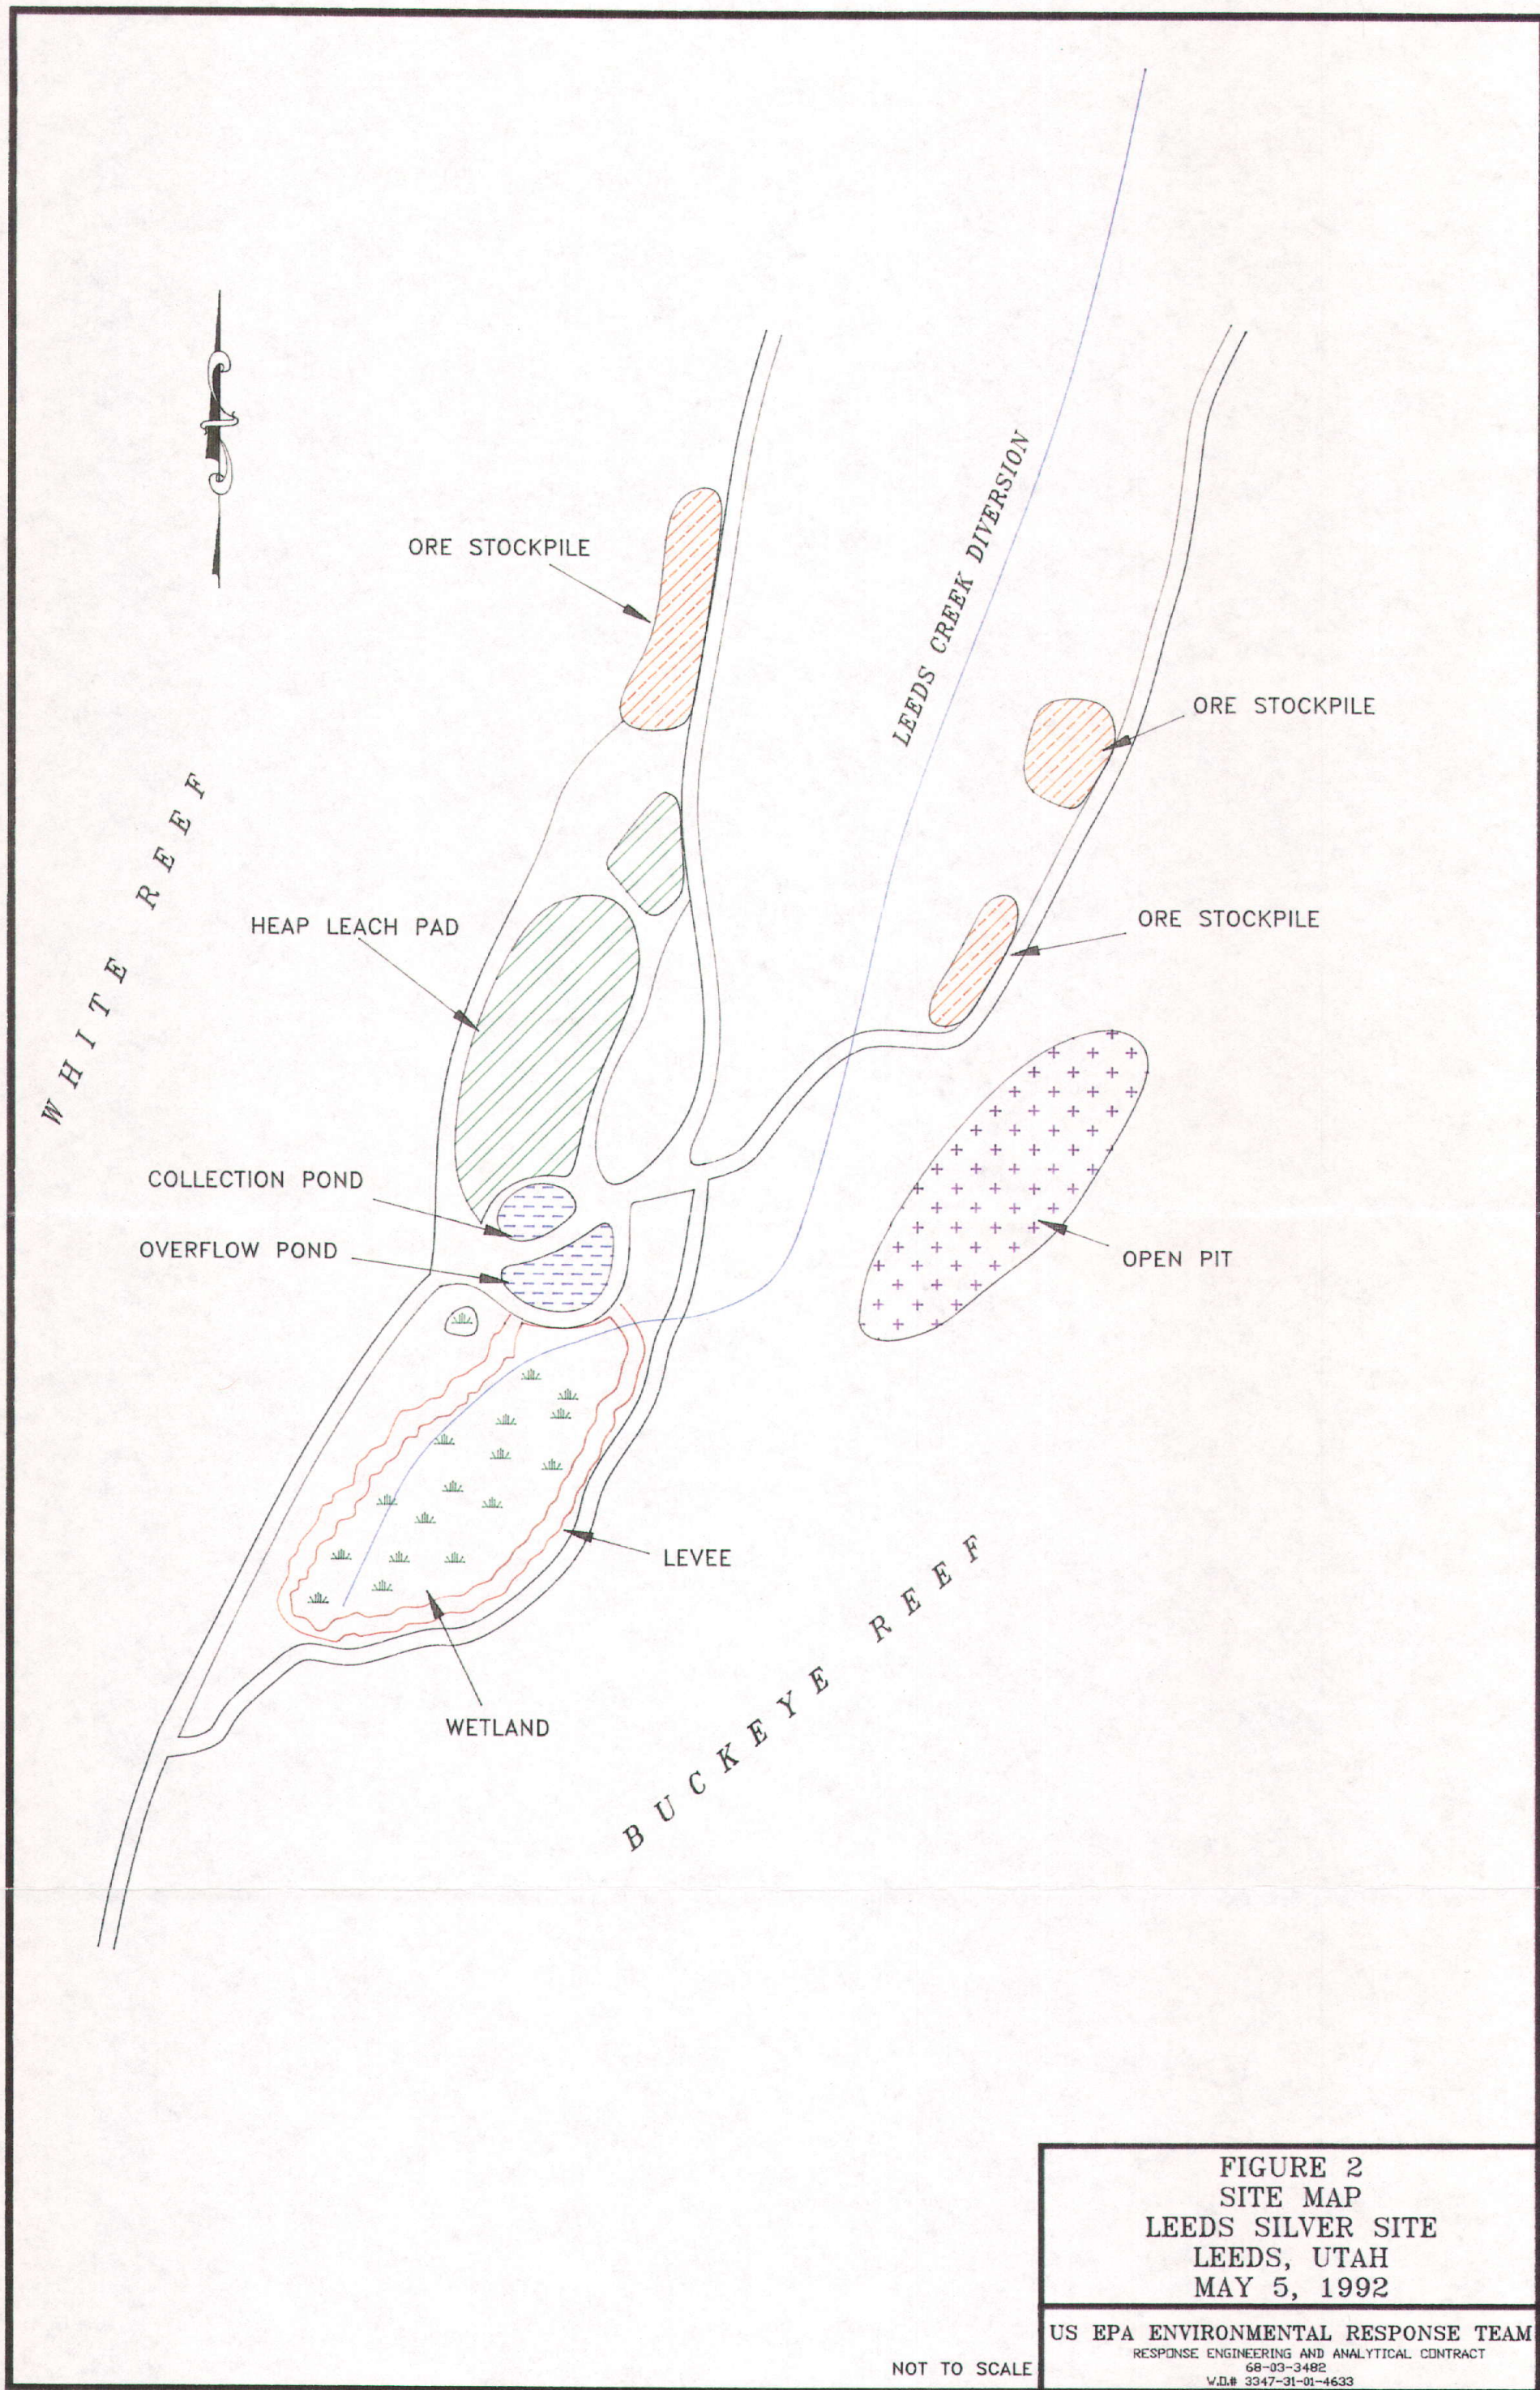
The site is located in a narrow, steep walled valley formed by Buckeye Reef to the southwest and White Reef to the northwest (Figure 2). Surface elevations range from approximately 3,640 feet at the northern extent of the site to approximately 3,520 feet at the southern extent. The main feature of the site is a centrally located pile of crushed ore underlain by an asphalt pad (Photo 1, background). This pad is oval in shape with a north-south orientation and slopes downward to the south. The asphalt pad covers an area of approximately 3.8 acres and, in conjunction with the ore, is referred to as a heap leach pad.<sup>(1)</sup> The leach pad is flanked to the south by a small collection pond, also referred to as the "pregnant pond", or "acidic water collection pond", (Photo 1, foreground) and south of this is an overflow pond, also referred to as "overflow reservoir" or "asphalt lined overflow pond", (Photo 2). The overflow pond is situated slightly downgradient of the collection pond and presumably designed to intercept and contain excess solution should the capacity of the collection pond be exceeded. Collectively, the ponds cover an area of approximately 0.9 acres and are also underlain by asphalt. A network of perforated polyvinyl chloride pipe traverse the surface of the ore pile and are used to distribute an acidic solution across the surface of the pile. As the acid solution percolates through the pile, it leaches metals from ore it comes in contact with. The metal bearing solution flows downslope along the pad and ultimately drains into the collection pond. The solution is pumped from the pond and silver, as well as other metals are recovered. At the time of the investigation, both ponds were partially full. The solution in the collection pond was clear but slightly green in color and the perimeter of the pond was ringed by a bright yellow precipitate (Photo 3). The solution

The highly disturbed nature of soils on site, particularly in the southern basin, provided sufficient justification to rely on vegetation and hydrological characteristics to a greater extent than soils in making this wetland determination. However, the presence of significant hydrologic indicators and facultative wetland species was sufficient evidence to classify the basin south of the collection and overflow ponds as wetlands using the 1989 Federal interagency methodology. The approximate extent of the Leeds Silver Site that possess the three criteria necessary to meet this regulatory definition of a wetland are mapped on Figure 2.

If any actions are to be taken at the Leeds Site a formal wetland delineation should be conducted. Additionally, a functional assessment of the existing wetlands would be needed if the wetlands are to be disturbed.

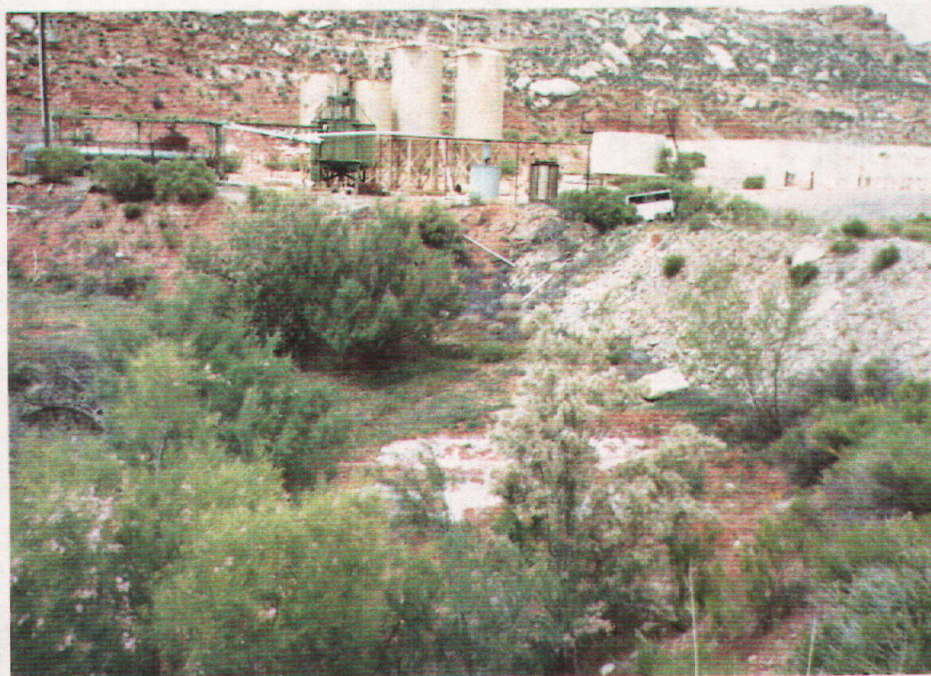
PHOTO 4 LEEDS SILVER SITE

North of the leach pad is a 1.3 acre ore stockpile and south of this stockpile, about half the distance to the leach pad, are several electrical transformers. An ore mill area covering 0.5 acres is present in the southwest corner of the site (Photo 4). Several electrical transformers are also present in the mill area. A warehouse and test area, also associated with on-site operations, are located approximately 1,000 feet northwest of the processing area. This warehouse also contains several transformers.

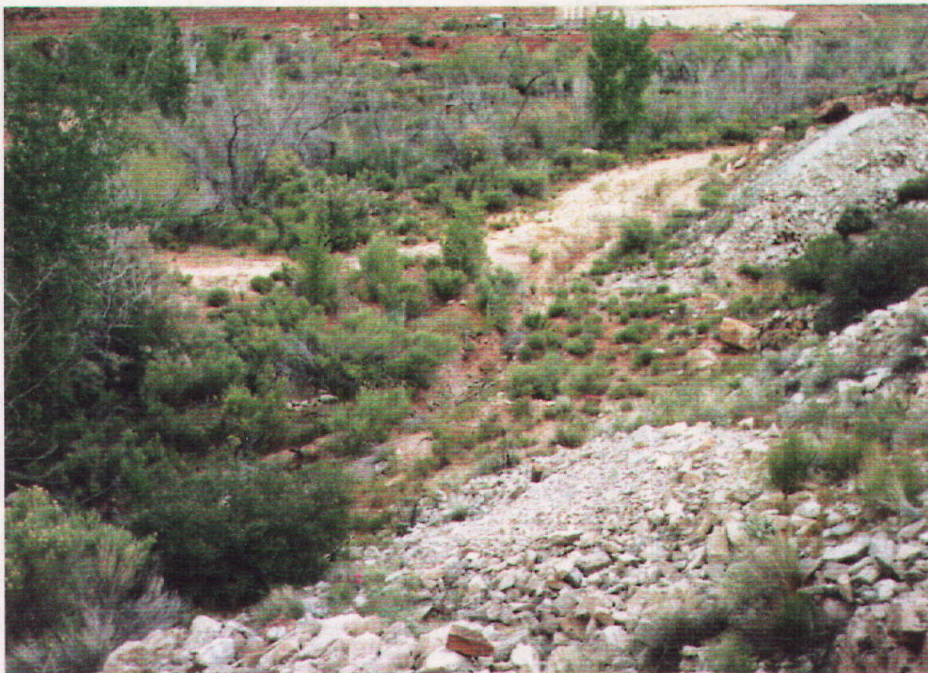
PHOTO 5 LEEDS SILVER SITE

South of the overflow pond, the valley becomes increasingly constricted between White and Buckeye Reefs. At the south end of the valley, the natural drainage is blocked by a dirt road, rubble associated with the California Mine, and an earthen levee (Photo 5). It appears that these features may contain most of the surface drainage from the site. Further, this configuration creates a basin that is referred to in-site documentation as a "secondary surface water impoundment", the "unlined secondary impoundment", or "storage ponds" that would contain runoff from the site should the ponds overflow.<sup>(1)</sup> A canal flows along Buckeye Reef and drains into the basin immediately south of the overflow pond (Photo 6). Within the basin, the canal is well defined and is approximately 18 inches in width and has a maximum depth of approximately eight inches (Photo 7). In the northern portion of the basin, the channel flows along the western levee and is situated somewhat higher in elevation than the basin floor. At the southern end of the basin, the canal drains into a partially filled mine shaft. South of the valley, the surface water flow drains into a pond utilized for irrigation supply and livestock watering (Photo 8). Depressional areas within the basin contained standing water and the soils were saturated at the surface (Photo 9). This appears to result from subsurface lateral seepage from the canal, as well as periodic overflow of the canal during storm events.

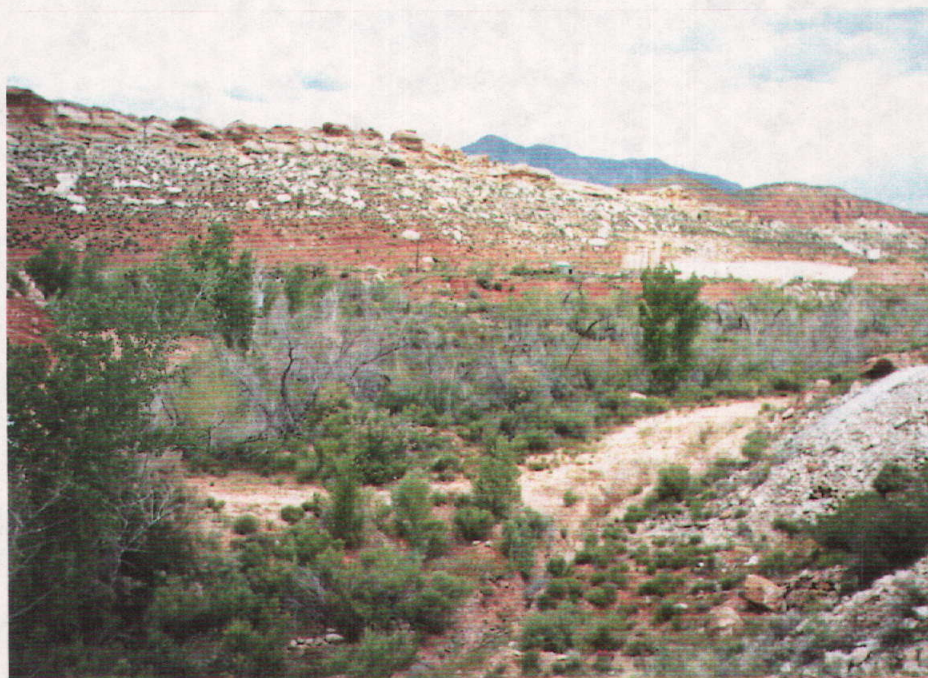
PHOTO 10 LEEDS SILVER SITE

brittlebush (Encelia sp.), scarlet mallow (Sphaeraleca coccinea), milk vetch (Astragalus sp.), antelope brush (Purshia tridentata), creosotebush (Larrea tridentata), blackbush (Coleogyne ramosissima), Mormon tea (Ephedra sp.), sage (Ambrosia sp.) and cactus (Opuntia sp. and Ferocactus sp.) were common (Photo 10). These species are typical desert plants adapted to an arid environment<sup>(5)</sup>. At the opposite end of the continuum, a wetland vegetative community is present (Photos 11 and 12). This community is dominated by rushes (Juncus spp.) and sedges (Carex spp.) with fewer numbers of fremont cottonwood (Populus fremontii), willow (Salix niger cf.), Tamarix (Tamarix sp.), and cattail (Typha sp.) were present as well.
